TECHNICAL GROUP BULLETIN

5-15-2013

COATS ROBO-ARM INSPECTION

PRODUCT AFFECTED: **All Coats Robo-Arms**

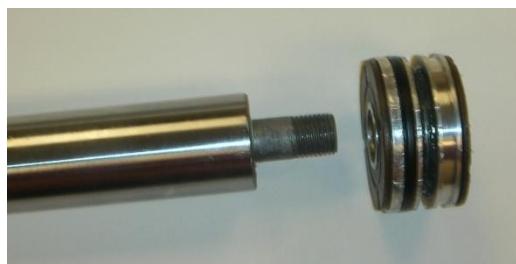
REASON: **The Coats Robo-Arm shaft screws into a piston inside the cylinder. If the shaft becomes loose it will cause the arm to not stay in the up position.**

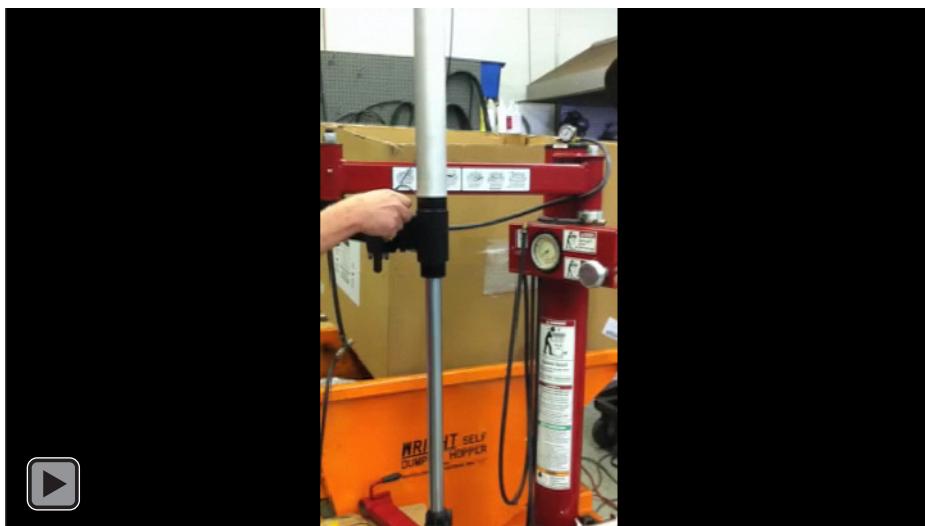
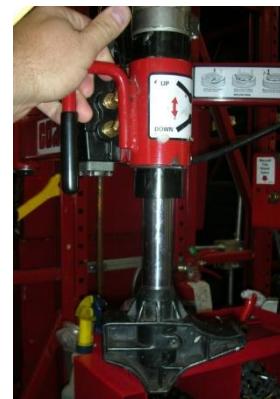
If the Robo-Arm does not stay in the "UP" position and creeps down then the cylinder has an internal leak and should be disconnected. Follow the disconnect instructions on page 2.

If you have a cylinder that does creep down please contact Gary Ruede at the Technical Department. 480-606-6261 or [grude@discounttire.com](mailto:gruede@discounttire.com)
