# TECHNICAL GROUP BULLETIN

## TRICO WIPER BEAM BLADES

PRODUCT  
AFFECTED: **All TRICO WIPERS**

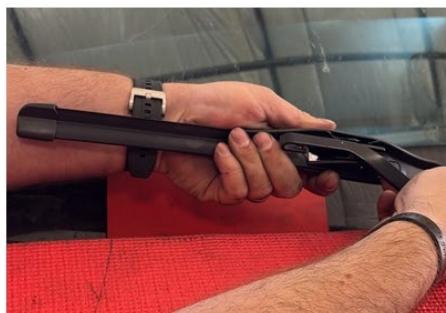
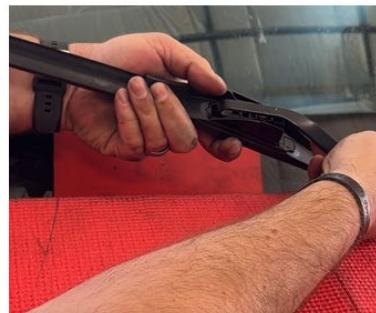
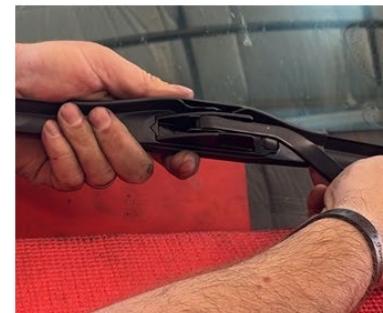
In some instances, we have discovered an issue where the wiper does not lock into place sufficiently. (see Images) We have no known instance of any safety issue. **This is a quality issue.**

When installing wiper blades align the wiper as shown and pull on it until you hear a click. Then verify that it is engaged by pushing on the blade. If it comes back off with little effort, then select another blade and contact your supervisor.

Reinforce our training to verify the beam style blades are installed correctly by pushing on the blade after it has been installed
